REPORT No. T 6/59

OPERATION ANTLER

The Effects of Blast on Dummies and Scout Cars

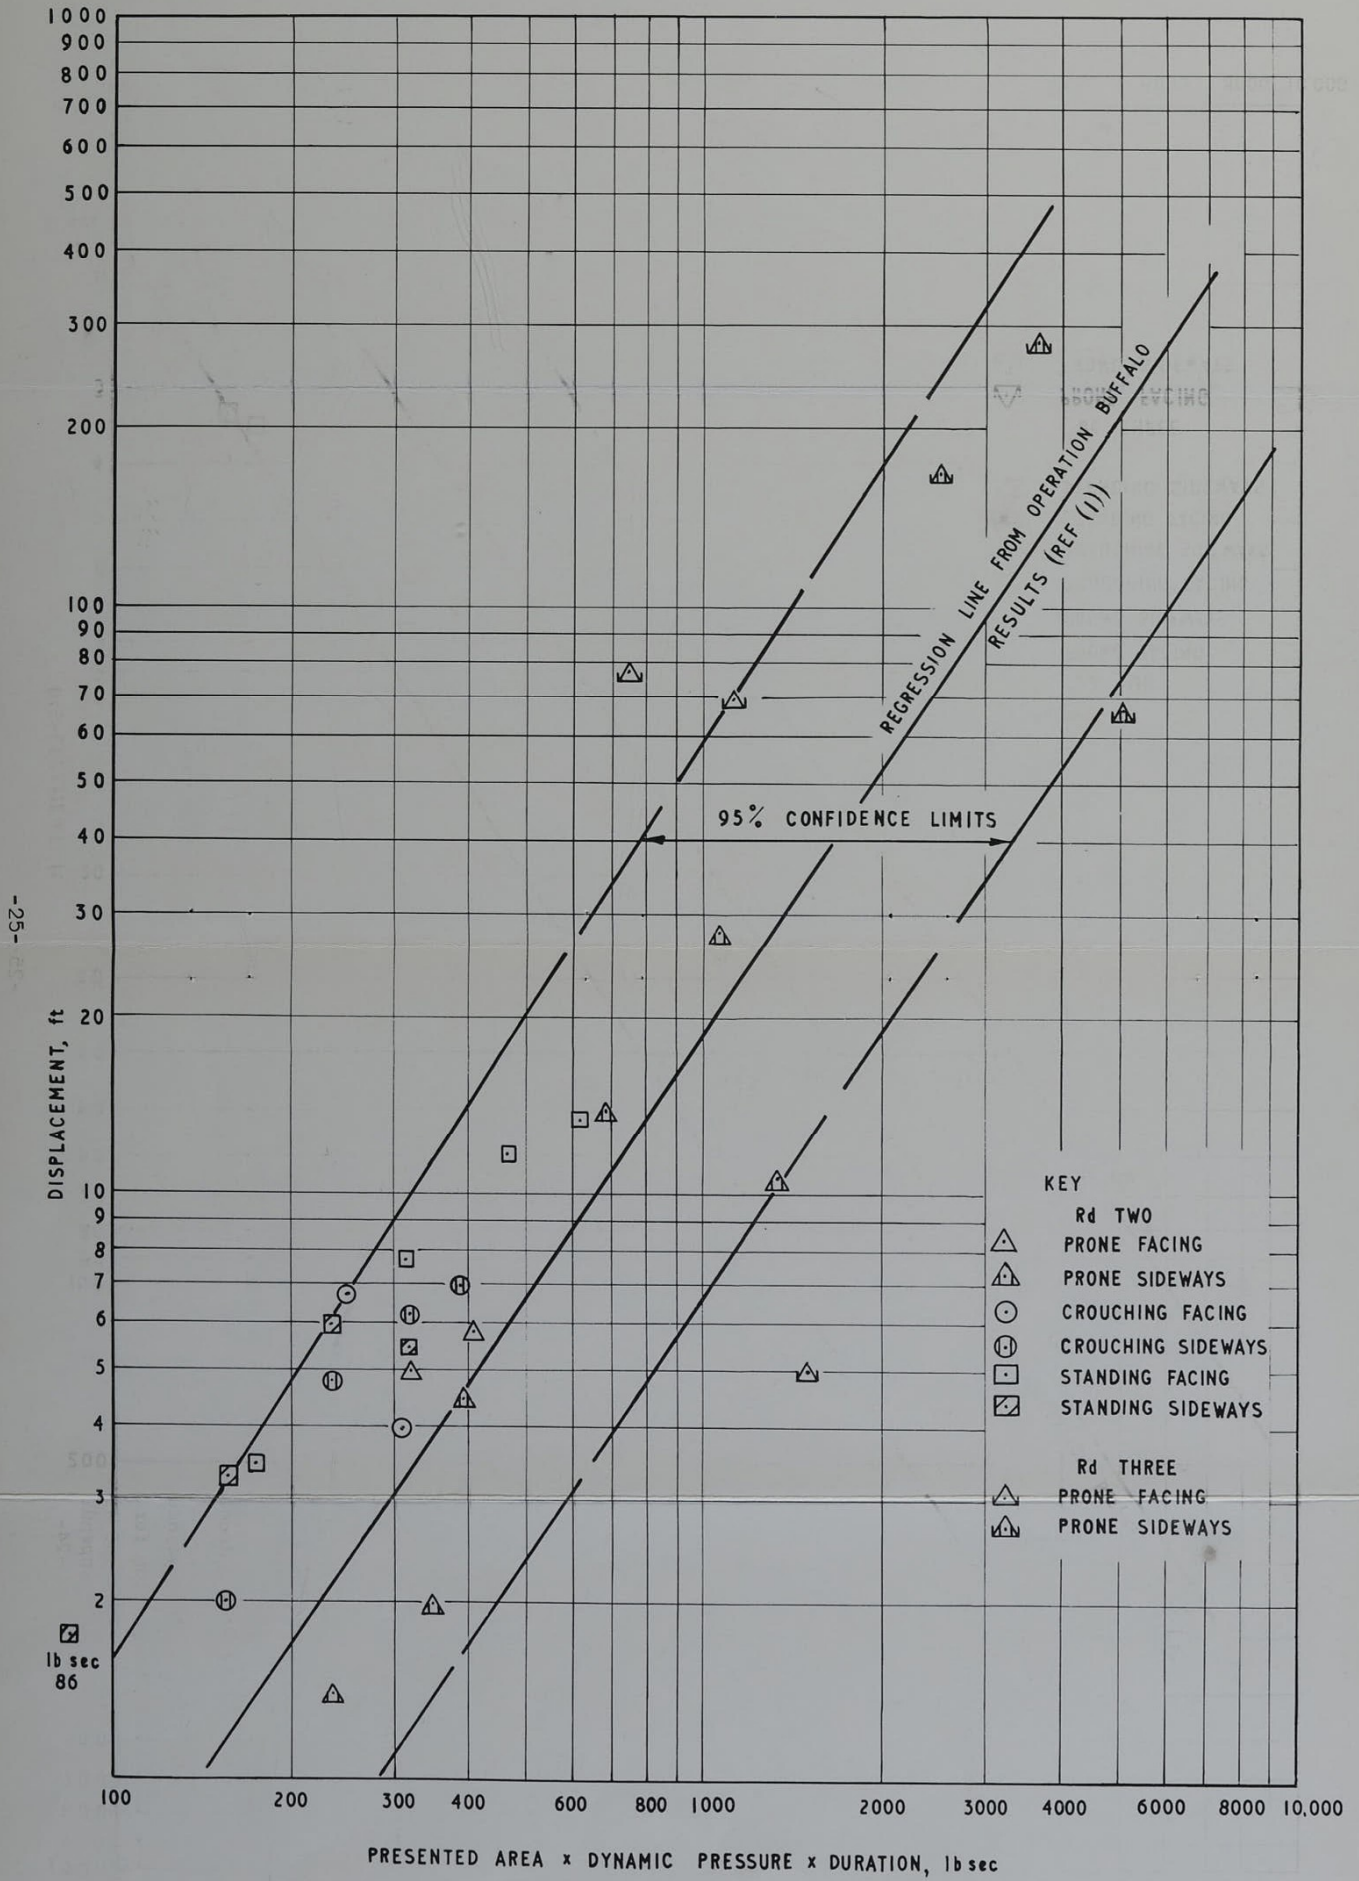
FIGURE 1

If Figure 1 the displacements of the dummies have been plotted against a quantity - the product of the peak

dynamic pressure, the positive phase direction and the presented area, which is proportional to the impulse received by the dummies. The quantity is not the impulse itself, since it takes no account of the hydrostatic pressure rise of very short duration, the drag coefficient of the dummies, or the decay of the dynamic pressure to zero at the end of the positive phase. The regression line with 95% confidence limits obtained from similar results from Operation Buffalo has also been drawn on the Figure.

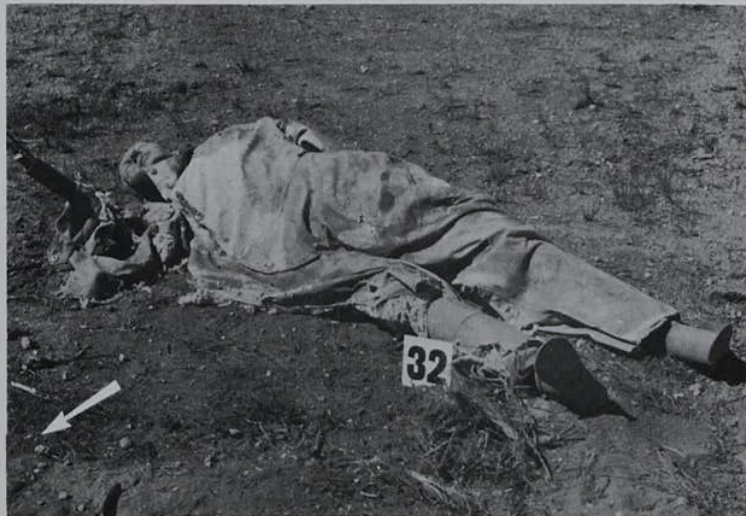
FIGURE 3. ROUND 2. PRONE SIDWAYS DUMMY AT 1460 ft OVERALL TORN AND CHARRED

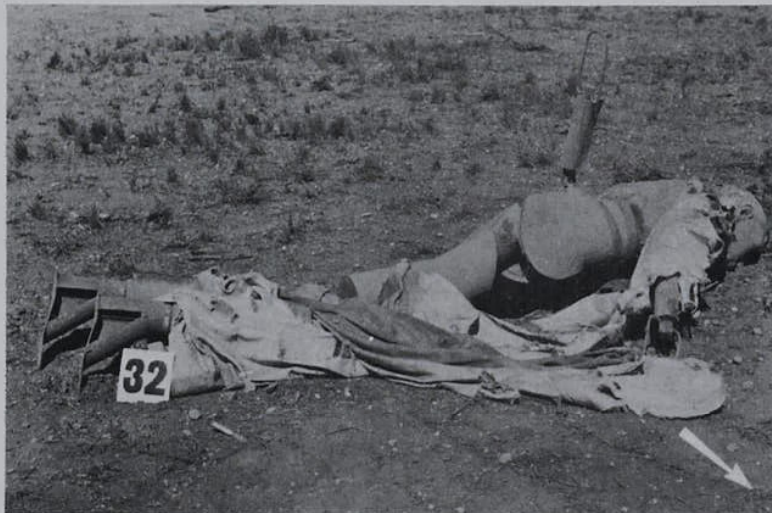
FIGURE 4. ROUND 2. PRONE FACING DUMMY AT 1460 ft
NOTE OVERALL ALMOST OFF, BUT FLESH ONLY
SLIGHTLY SCORCHED

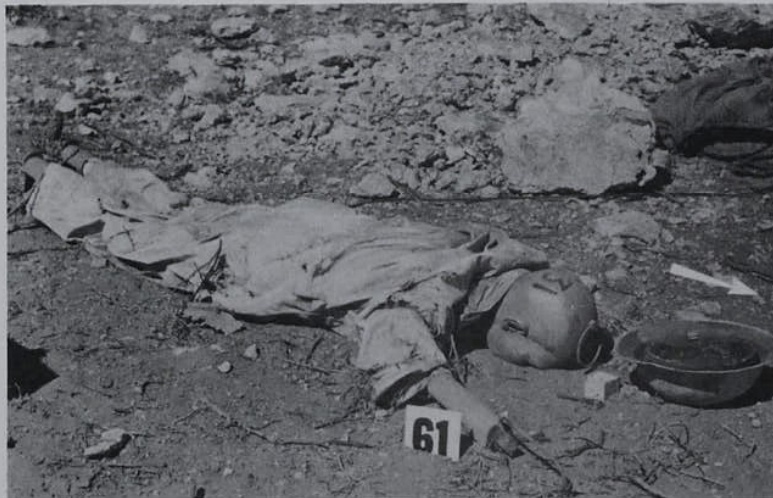
With dummies facing the blast, either prone or crouching, the helmet often remained on the head throughout the positive phase.

FIGURE 5. ROUND 2. PRONE FACING DUMMY AT 1840 ft
NOTE HELMET WHICH REMAINED ON HEAD
DURING POSITIVE PHASE OF BLAST

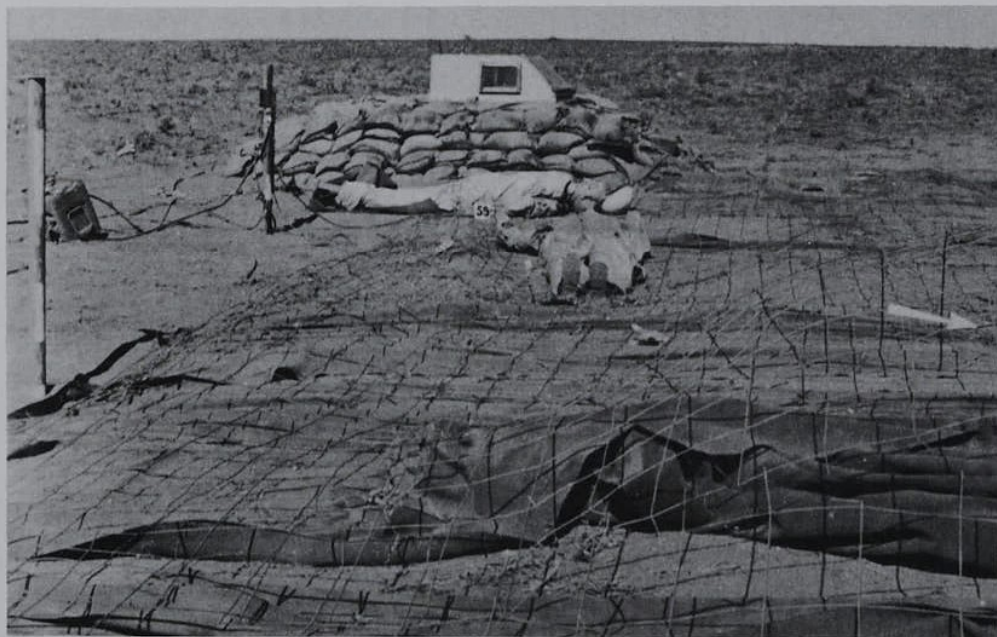
FIGURE 7. ROUND 2. PRONE DUMMIES AT 2000 ft AFTER FIRING.
NOTE WIRE MESH HAS IMPEDED MOTION OF PRONE
SIDWAYS DUMMY

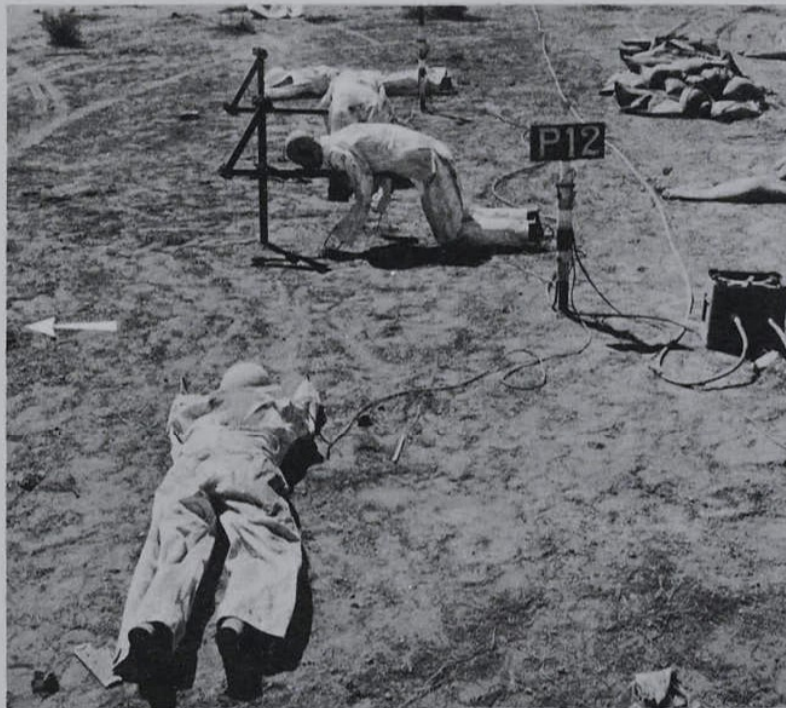
FIGURE 8. ROUND 2. PRONE AND CROUCHING DUMMIES AT 2200 ft BEFORE FIRING. NOTE INSTRUMENTATION LIABLE TO CATCH IN FEET. SANDBAGS WERE REMOVED BEFORE FIRING

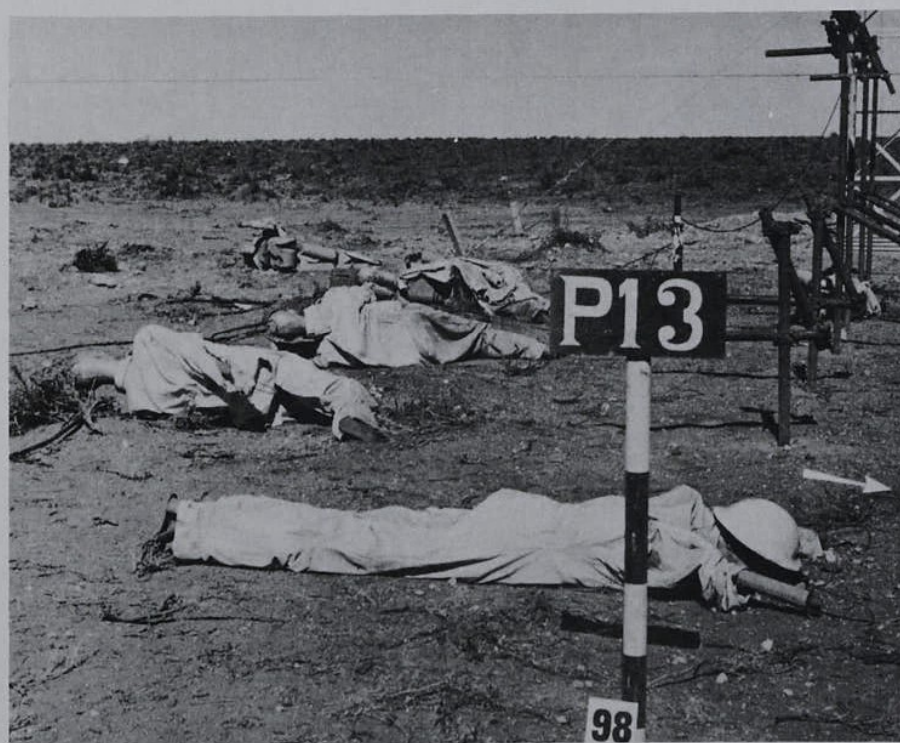
FIGURE 11. ROUND 2. DUMMIES AT 2390 ft AFTER FIRING.
NOTE CAMERA TOWER IN BACKGROUND, AND
LACK OF MOVEMENT OF THE PRONE FACING DUMMY

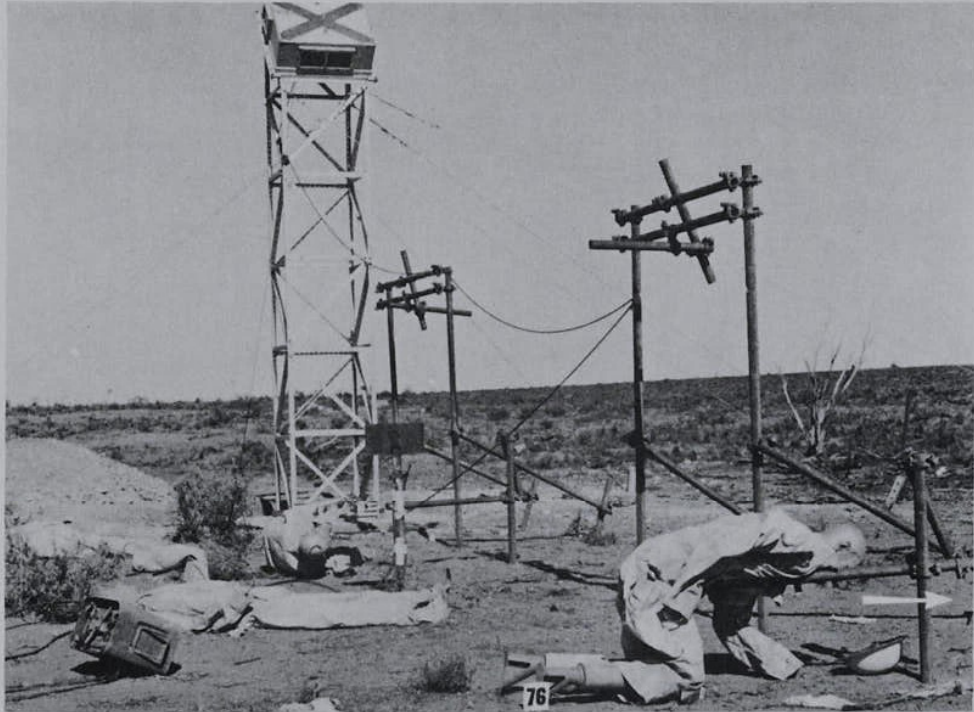
FIGURE 12. ROUND 2. DUMMIES AT 3100 ft AFTER FIRING. NOTE
CROUCHING FACING DUMMY HAS REMAINED ON THE
SUPPORT AND HELMET HAS DROPPED OFF AFTER
POSITIVE PHASE

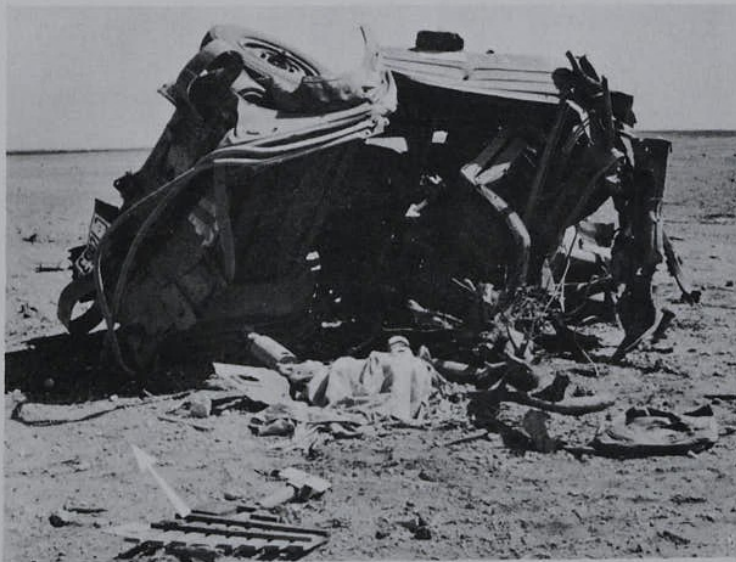
FIGURE 13. ROUND 3. CHAMP AT 1860 ft. NOTE LOWER HALF
OF DUMMY DRIVER IN WRECKAGE

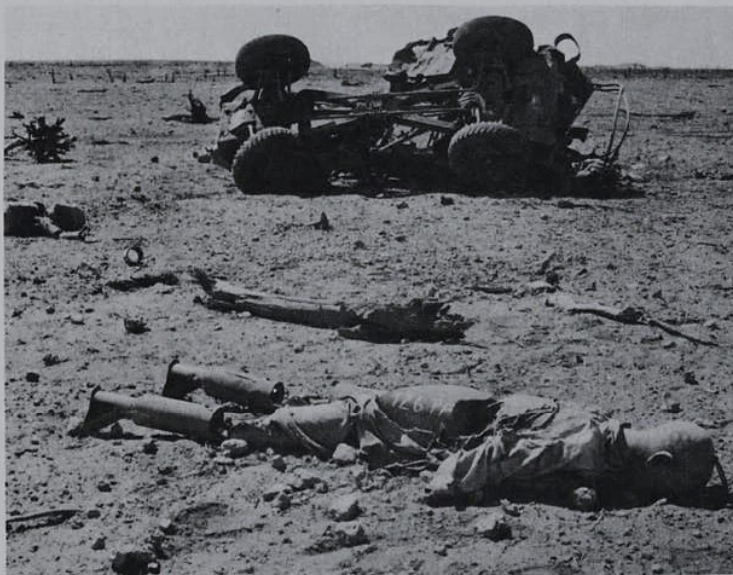
FIGURE 14. ROUND 3. PASSENGER OF CHAMP AT 1860 ft.
NOTE UPPER PART OF DUMMY DRIVER IN
FRONT OF CHAMP

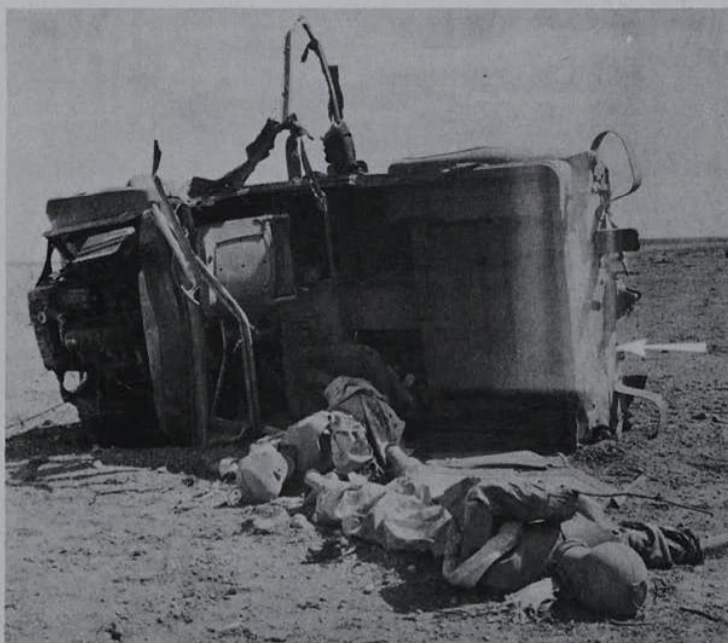
FIGURE 15. ROUND 3. CHAMP AT 2110 ft SHOWING
DRIVER AND PASSENGER THROWN OUT
OF VEHICLE

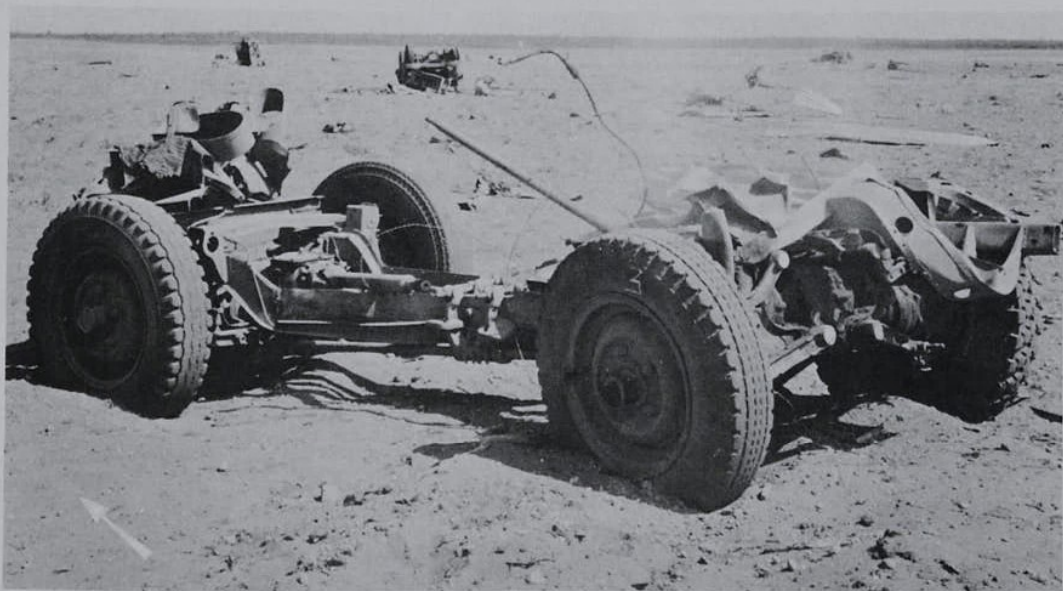
FIGURE 16. ROUND 3. VIEW OF FRONT 4 CHAMPS AFTER FIRING
WITH SCATTERED DEBRIS

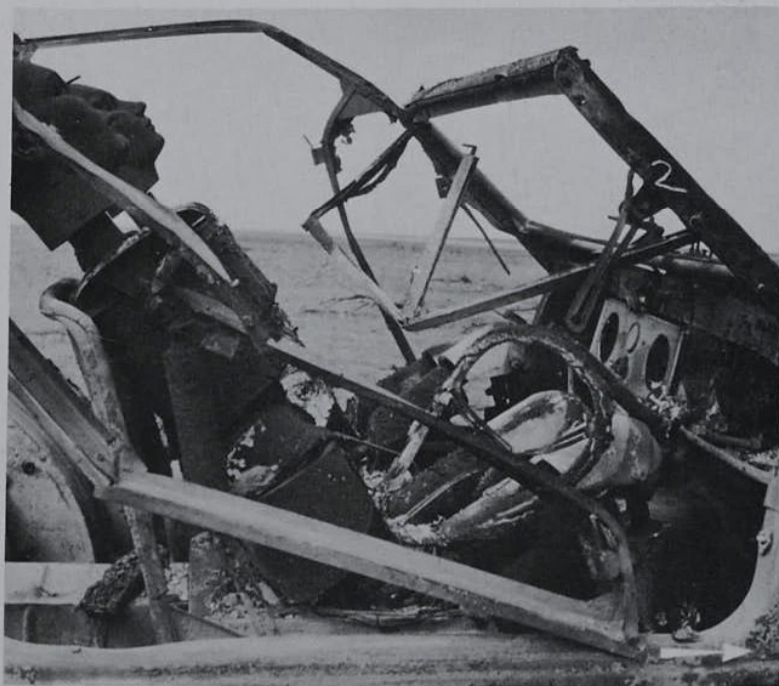
FIGURE 17. ROUND 3 . CHAMP AT 2630 ft DUMMIES BURNT
IN SITU BY PETROL FIRE

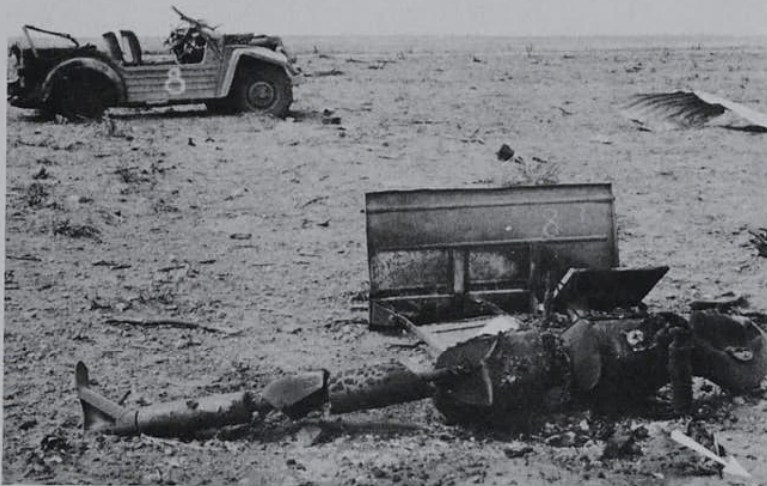
FIGURE 18. ROUND 3. DUMMY PASSENGER FROM CHAMP
SIDEWAYS TO BLAST AT 2825 ft BURNT OUT
AND WITH ONE LEG MISSING

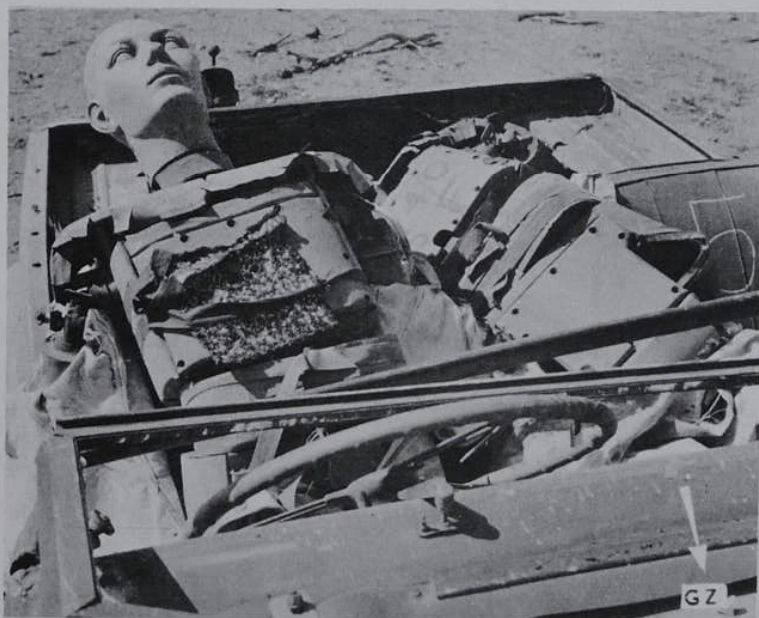
FIGURE 19. ROUND 3. CHAMP AT 2920 ft NOTE CONDITION
OF SPANDOPLAST ON DRIVERS CHEST WHICH HAS
SHRIVELLED WITH HEAT

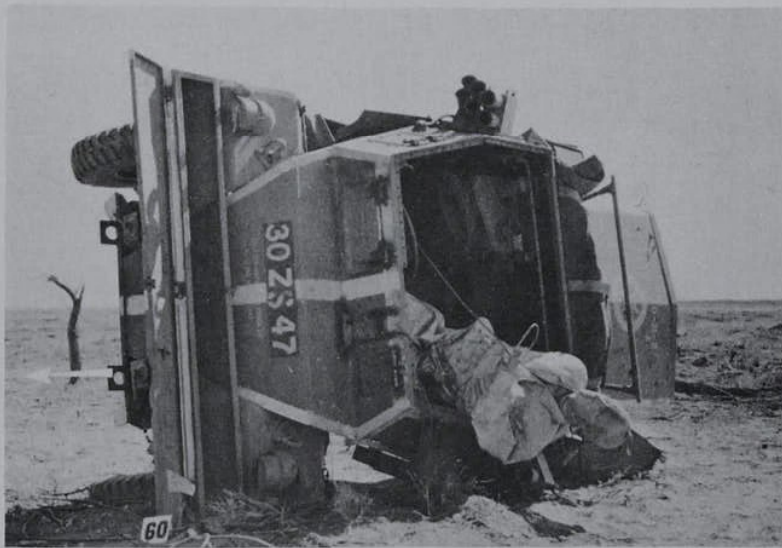
Because the yield of the weapon actually fired was much lower than had been assumed in the initial target response planning, only minor damage was done to the Scout Cars and so little new data were obtained. However, the critical conditions for overturning a Daimler Scout Car sideways on to the blast were bracketted, the car at 1730 ft from Ground Zero of Round 2 was turned over while the one at 2360 ft was not.

FIGURE 21. ROUND 2. SCOUT CAR AT 1730 ft AFTER FIRING.
NO APPARENT DAMAGE TO DUMMY OR SCOUT CAR
WHICH SIMPLY TURNED OVER ONTO ITS SIDE

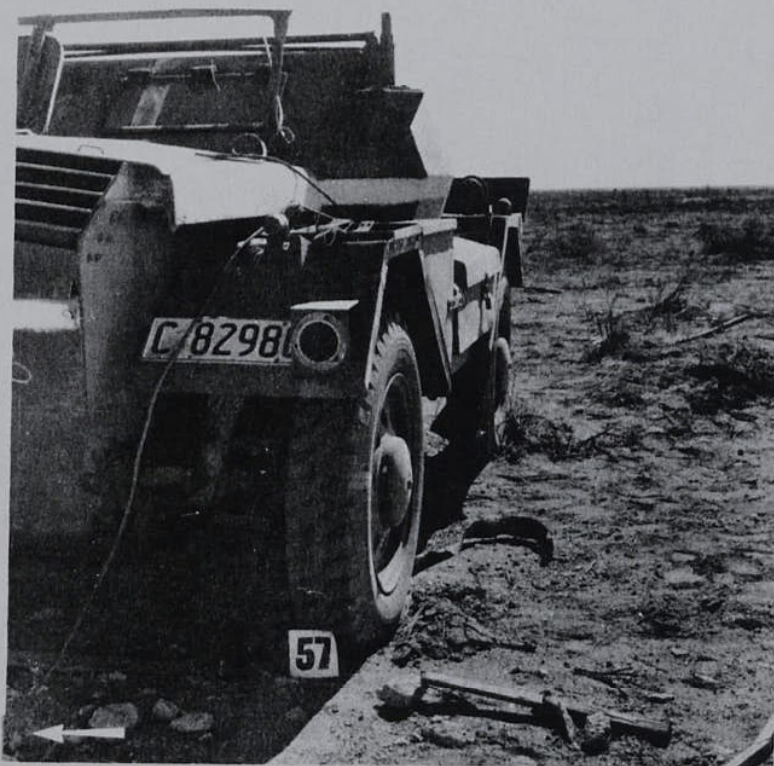
FIGURE 22. ROUND 2. SCOUT CAR AT 2200 ft AFTER
FIRING. NOTE SOIL DISPLACED BY WHEEL
WHEN CAR MOVED SIDWAYS 4 INCHES

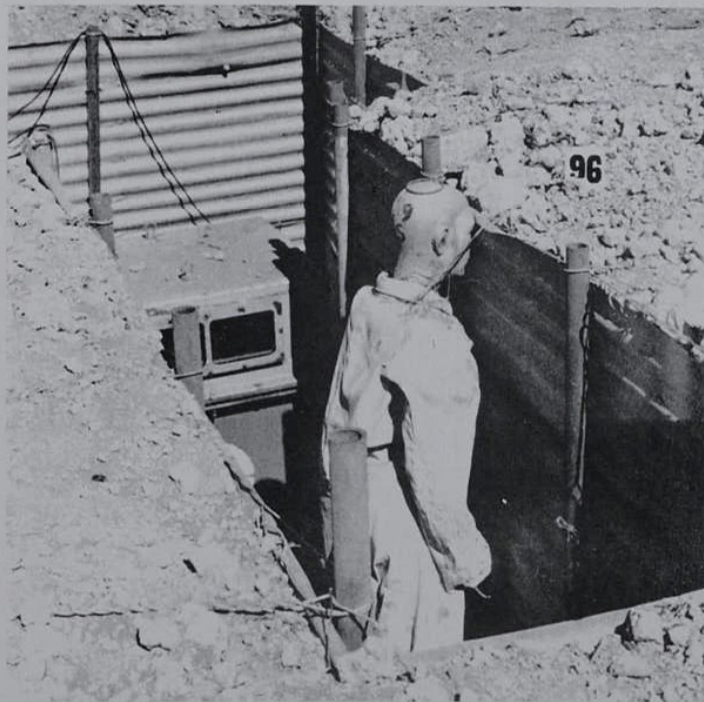
FIGURE 24. DUMMY IN TRENCH AT 2390 ft AFTER FIRING

On Round 2, one dummy was standing in a trench which was at right angles to the radius from Ground Zero at Site P17 (2390 ft). The dummy was facing Ground Zero with the rim of its steel helmet about level with the lip of the trench (see Figure 23). This dummy was exposed primarily to test a camera installation, but after firing it was observed that it had not moved and had apparently suffered no damage (see Figure 24).
